260-IN.-DIA MOTOR FEASIBILITY
DEMONSTRATION PROGRAM (u)

STATIC TEST FIRING OF MOTOR 260-SL-2
FINAL REPORT

NASA CR-54982

25 MARCH 1966

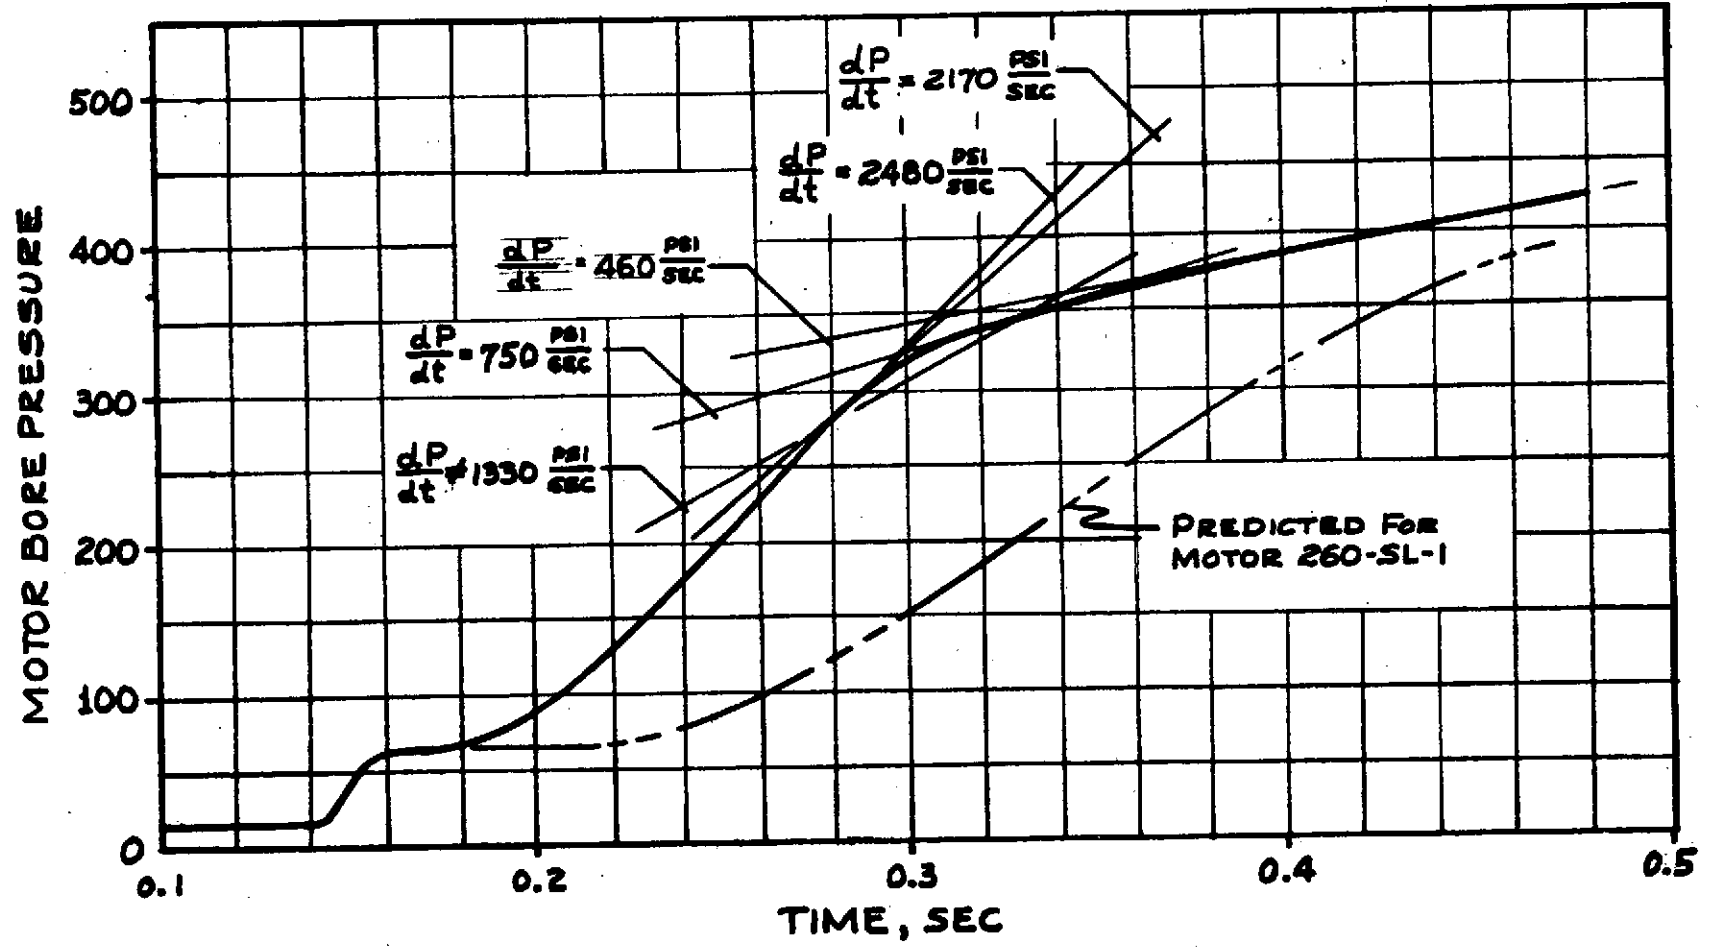
Figure 54

In Figure 54, the calculated slopes were superimposed on the measured 260-SL motor pressure rise curve. An excellent correlation was obtained, except for the condition at 350 psia; the solution to the equation obviously did not represent the true flow conditions at this pressure level. The measured rate of pressure rise at 350 psia was approximately 750 psi/sec; the calculated effective motor throat area necessary to obtain this rate of pressure rise was approximately 3960 sq in., or the full 260-SL motor throat area. Extending the analysis to 400 psia, the calculated rate of pressure rise was 460 psi; these values were in close agreement with both the measured and predicted motor pressure rise rates (500 psi/sec average between 300 and 500 psia).

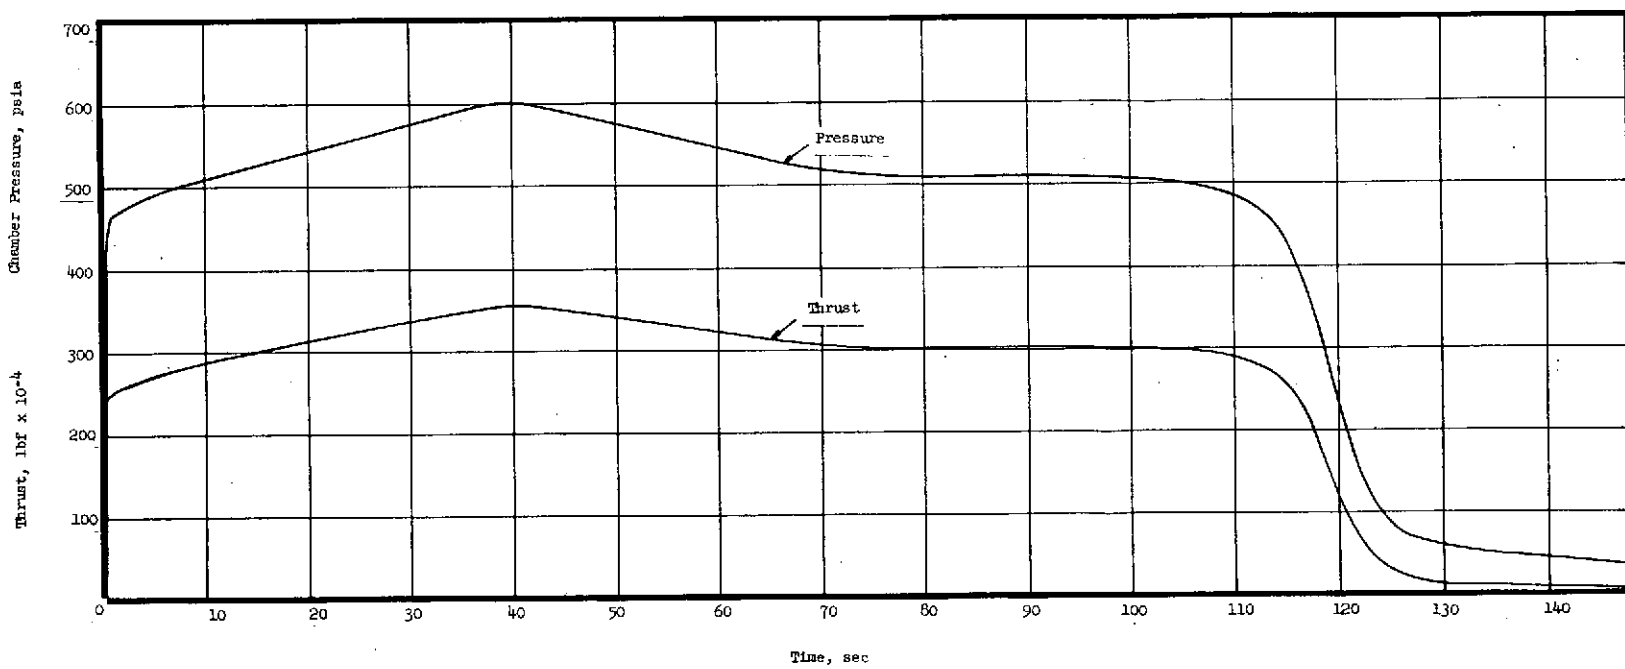
Figure 56

The ballistic performance characteristics of motor 260-SL-2 were in close agreement with those predicted and all design objectives were met. A summary of predicted and actual performance characteristics is presented in Figure 55. The measured 260-SL-2 chamber pressure- and thrust-vs-time curves are shown in Figure 56.

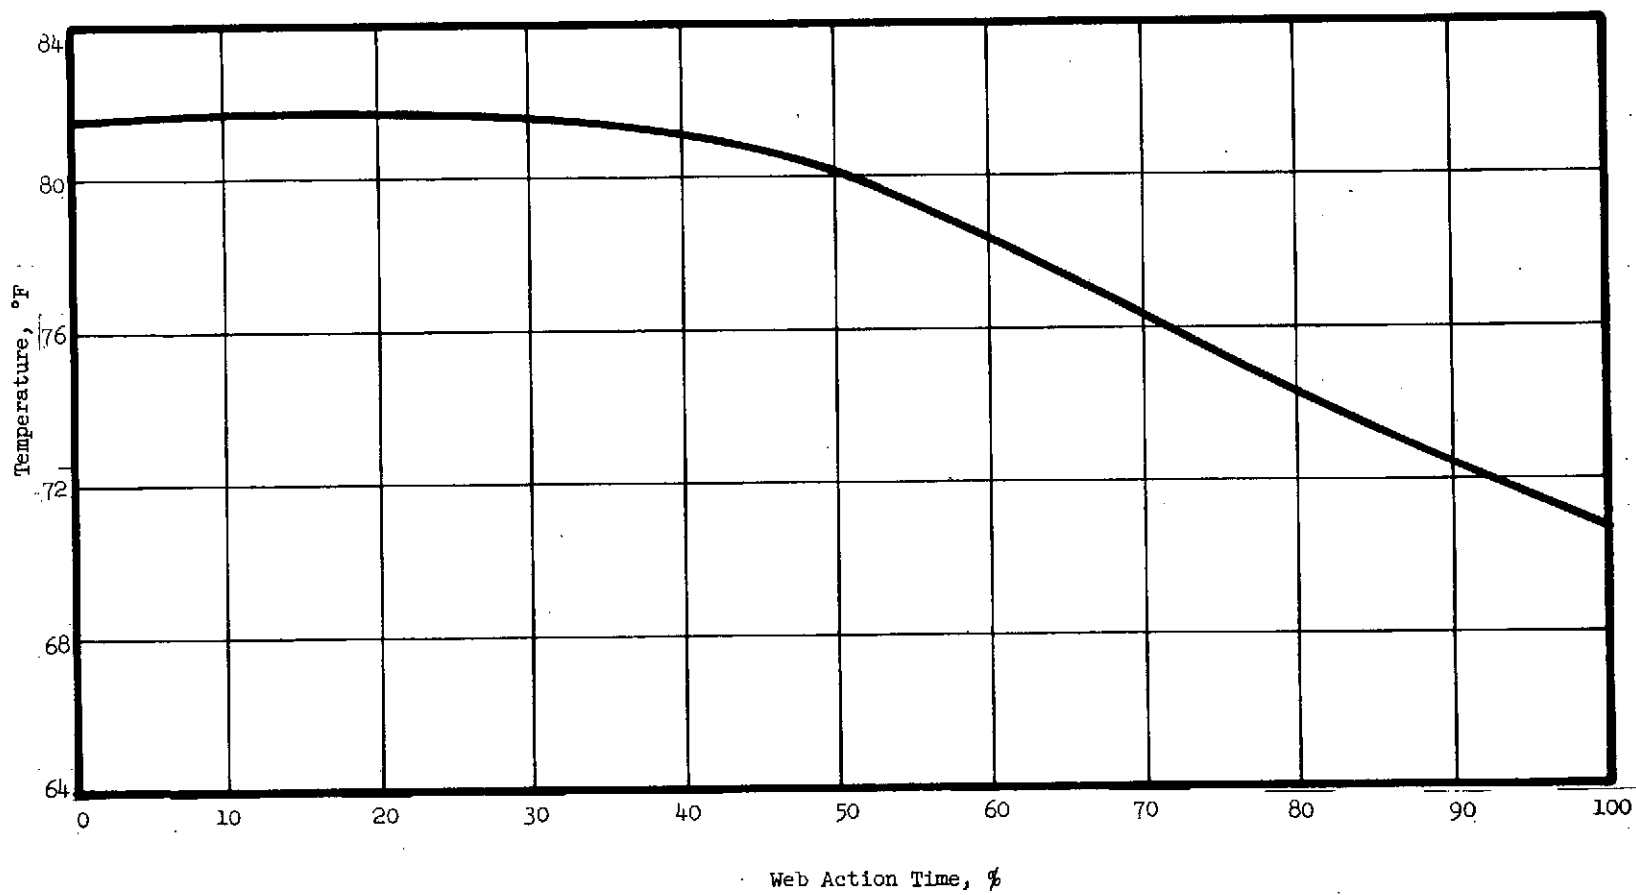
Figure 58

An allowance for the temperature gradient in the grain was made by adjusting the burning rate as a function of burning time. The grain temperature gradient, shown in Figure 58, was calculated from the grain environmental temperatures during cure, cooldown, and final assembly. Because of low ambient air temperatures during final assembly of motor 260-SL-2, the calculated average grain temperature was about 8°F lower than that of motor 260-SL-1.

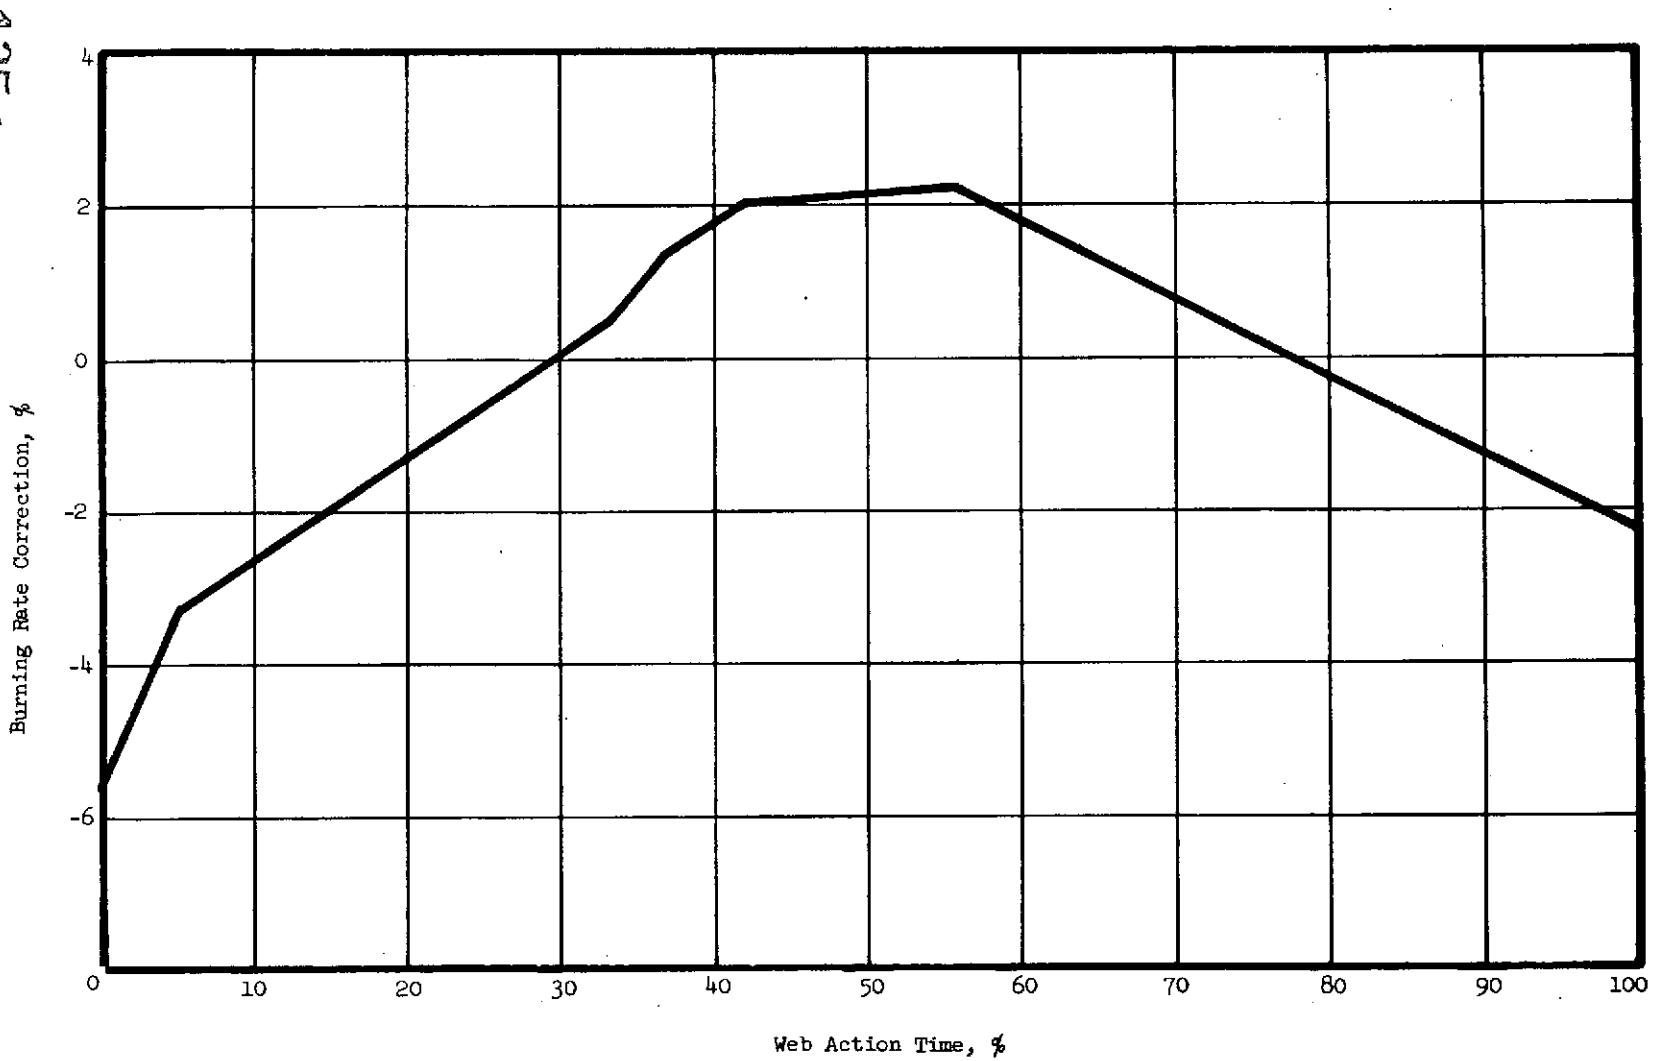
Figure 59

adjusted radially, based on an empirical correlation developed from the ballistic performance of the 44-SS and 120-SS-1 motors. However, the adjustment used in the 260-SL-2 prediction was revised on the basis of the actual 260-SL-1 motor performance. The revised burning rate correction-vs-percent of web action time characteristic is shown in Figure 59. In addition, an axial burning rate adjustment, shown in Figure 60, was applied to simulate the effect of batch-to-batch burning rate variation on the shape of the curve during tailoff.

Burning Rate Correction as a Function of Web Action Time

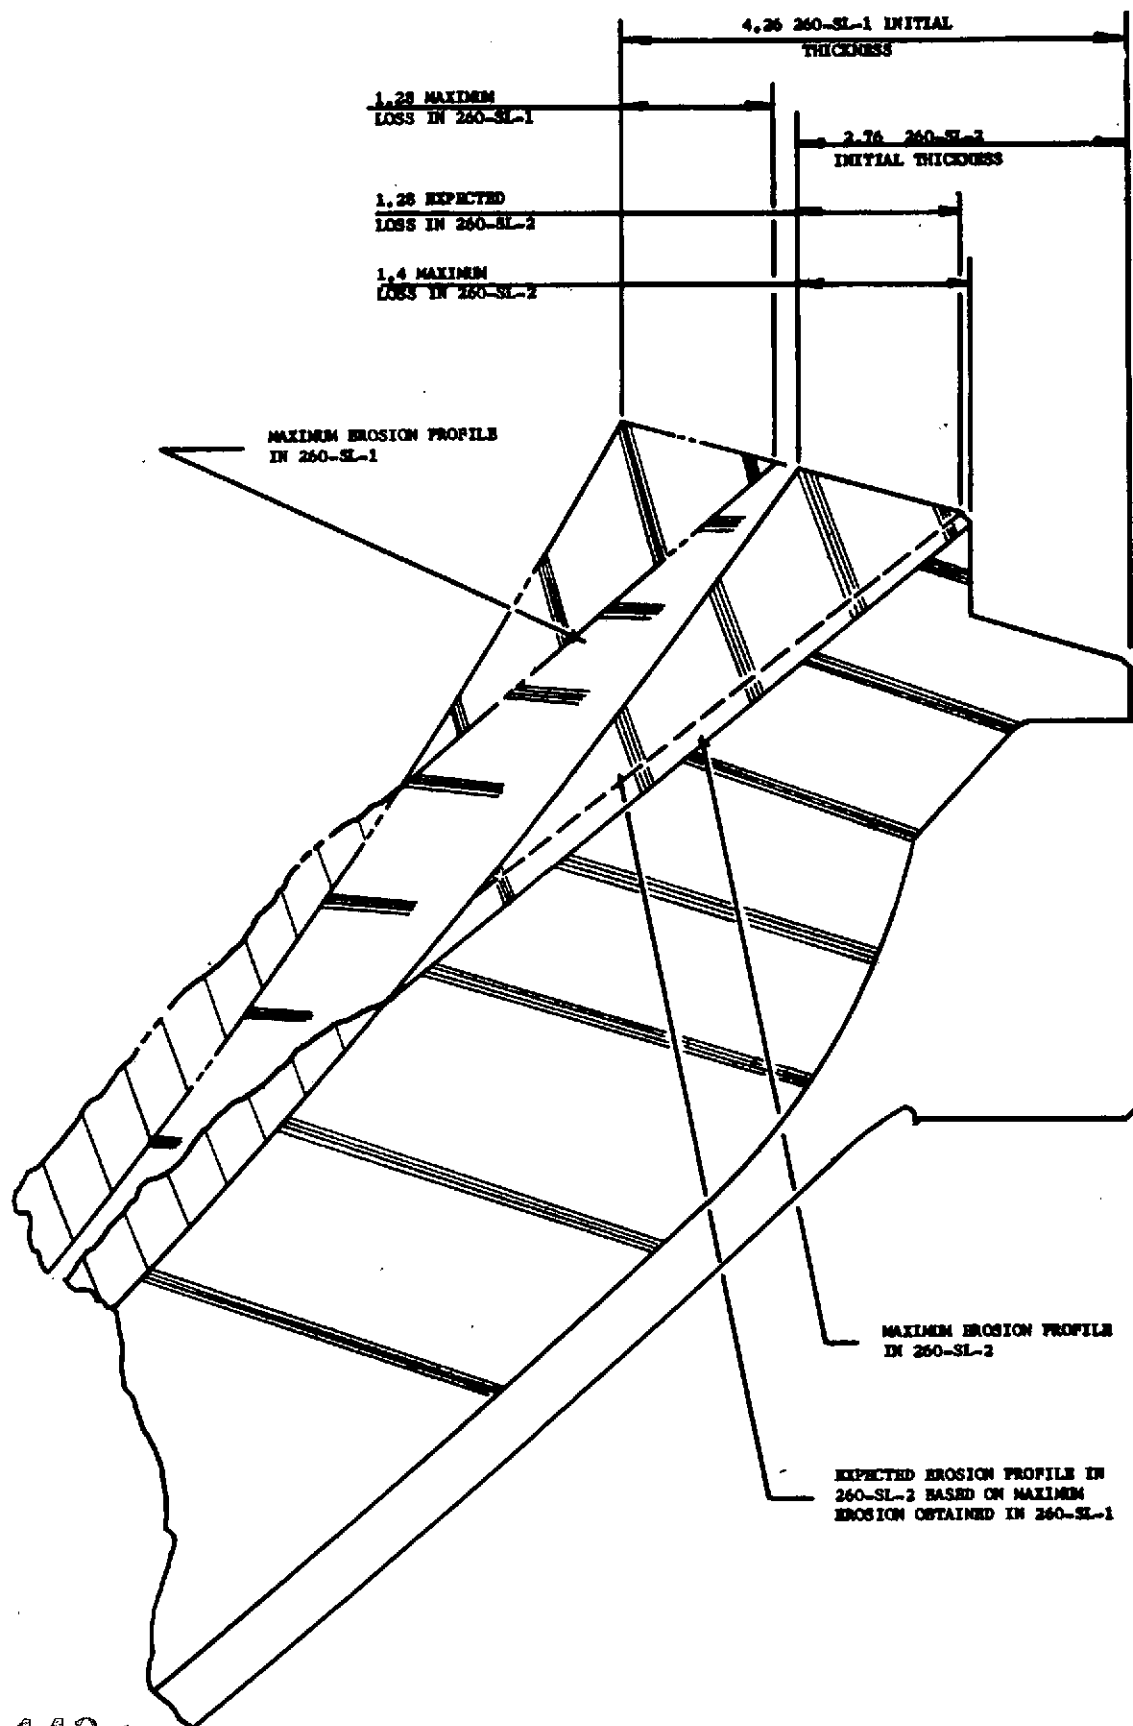
Figure 67

The aft-head insulation posttest measurements are shown in Figure 65. The FMC-200 potting compound between the aft boot and insulation was not totally burned away and was effective in protecting the insulation from approximately 6 to 8 in. forward of the nozzle step-joint to the boot bond areas, as shown in Figure 66. The maximum rubber erosion occurred in the 190-degree area. Again, meaningful rubber thickness loss rate data was affected by the potting material. However, the observed maximum rubber thickness loss in motor 260-SL-2 was similar to the thickness loss in 260-SL-1. As shown in Figure 67, the expected material thickness loss for 260-SL-2 aft insulation was 1.28 in.*, based on the measured maximum thickness loss in 260-SL-1. The maximum measured thickness loss in 260-SL-2 was 1.4 in.* (Figure 67).

Predicted and Actual Aft Head Insulation Erosion

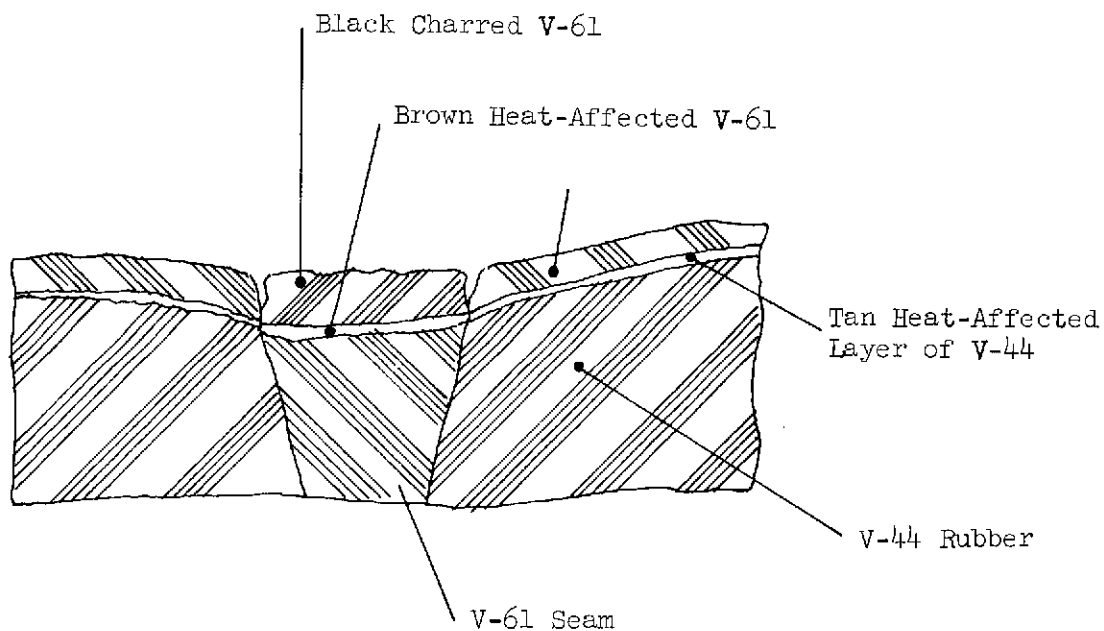
Forward Seam (Aft of 180 in. Diameter)

Posttest Condition of Motor 260-SL-2 Insulation Seams

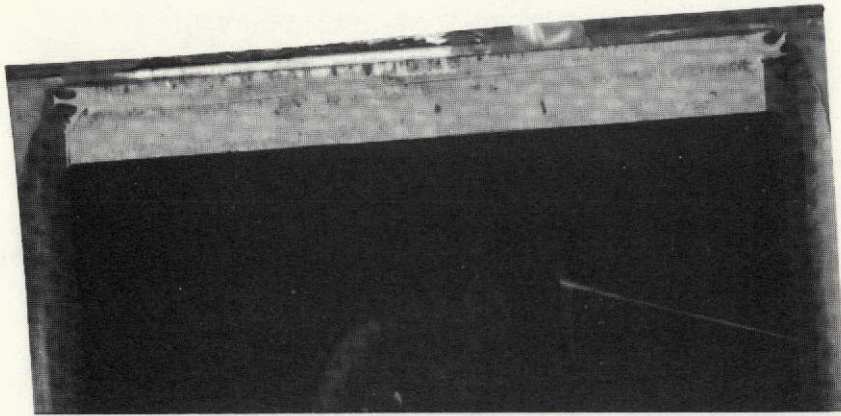
Posttest View of Firing Cap Insulation

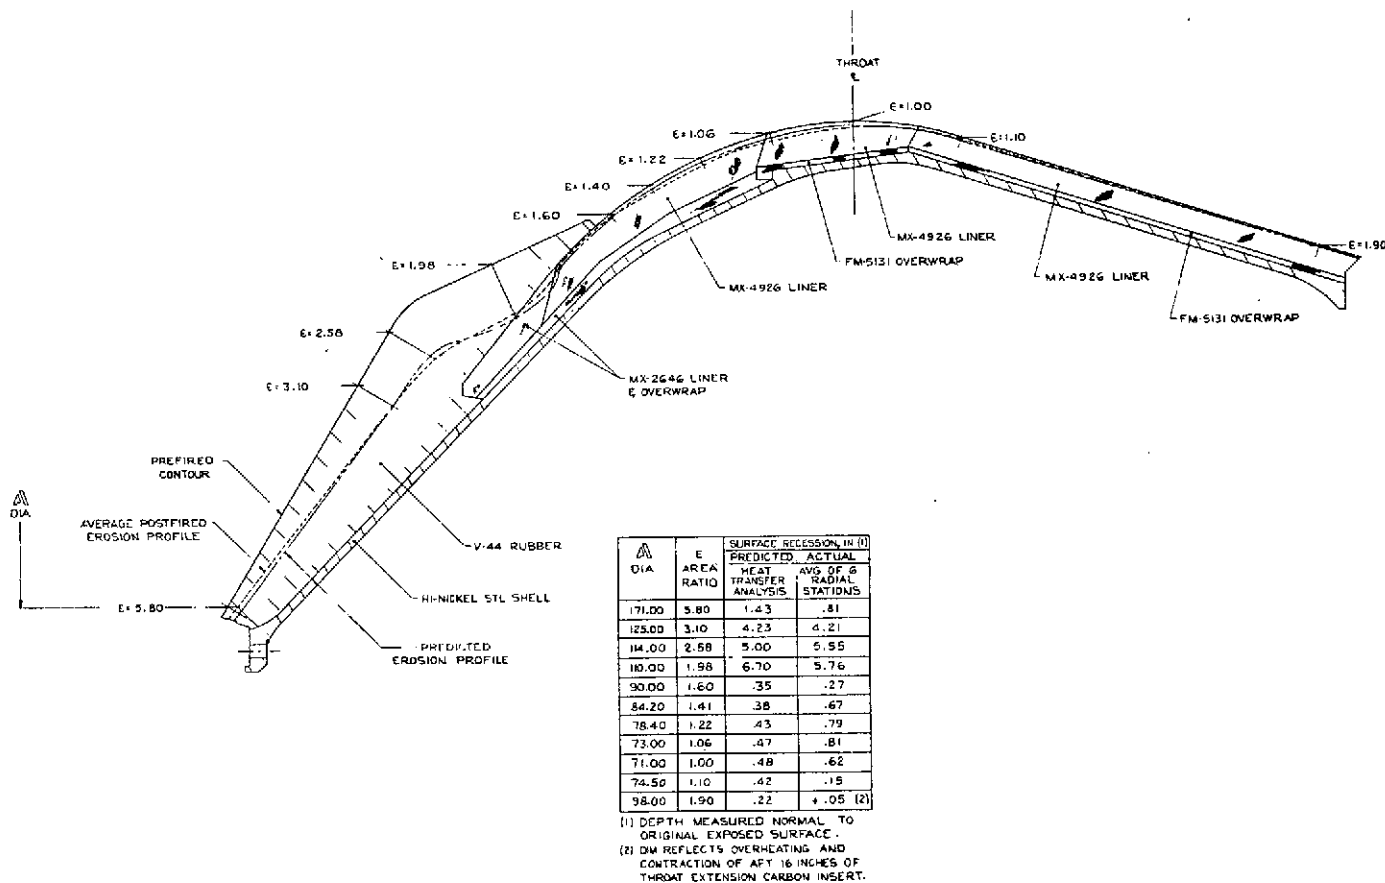
Figure 71

A summary of erosion depths obtained from profile measurements is tabulated in Figure 70. The average erosion profile of the nozzle assembly is shown in Figure 71. The average nozzle throat erosion is 0.624 in. and agrees with the average of six posttest throat diameter measurements taken. Figure 72 compares nozzle insert erosion of motors 260-SL-1 and -2.

Nozzle Surface Recession Profile, Motor 260-SL-2

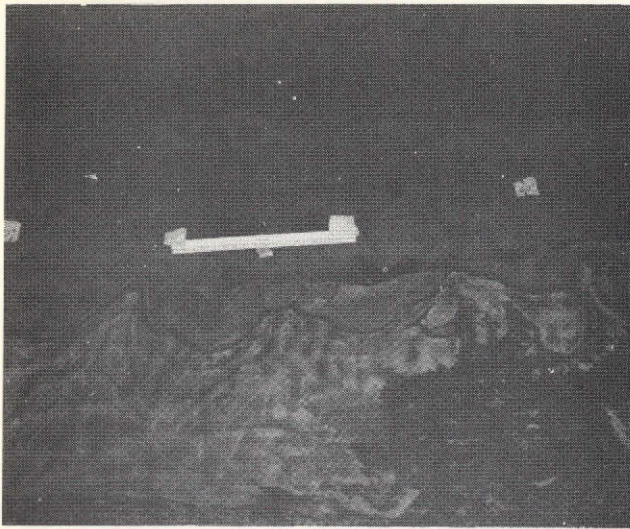
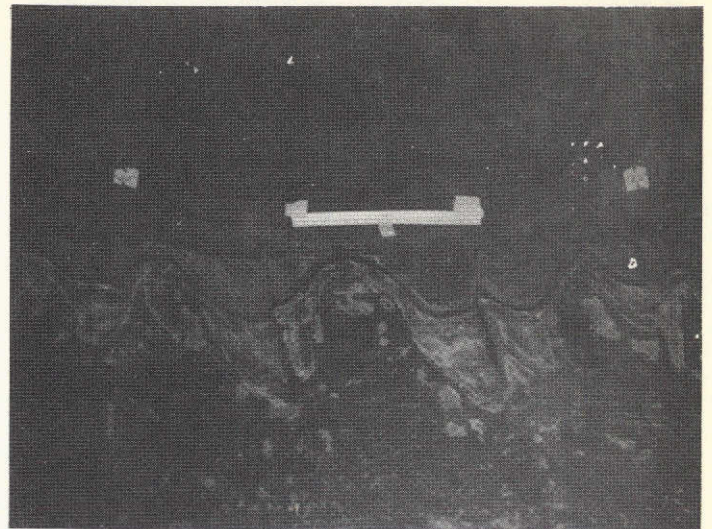
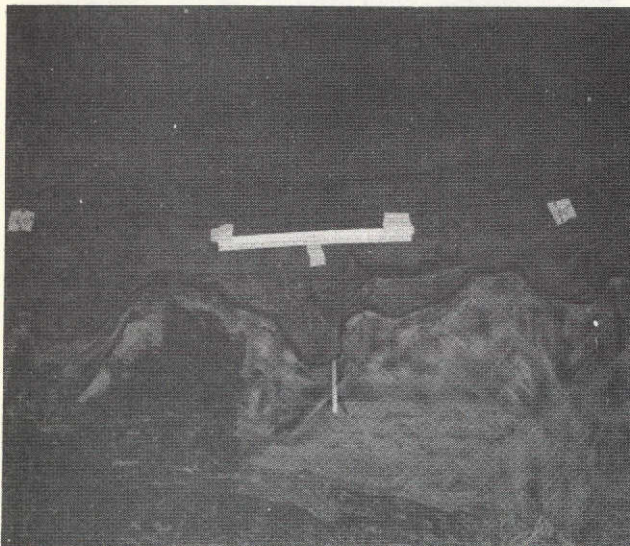
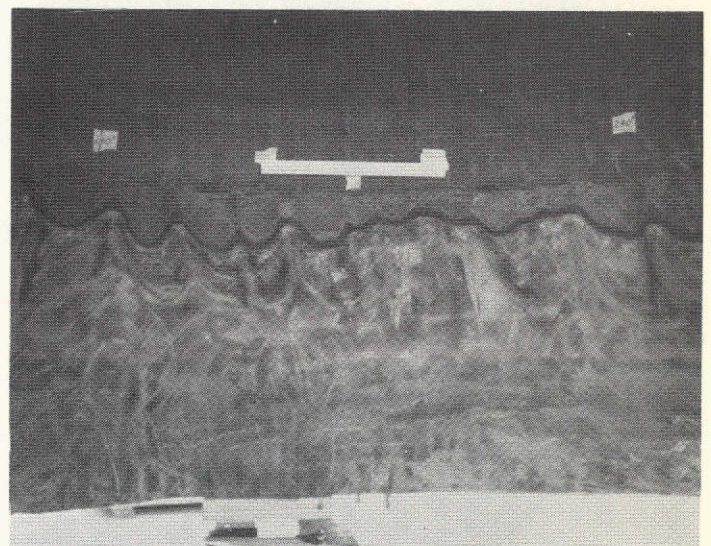
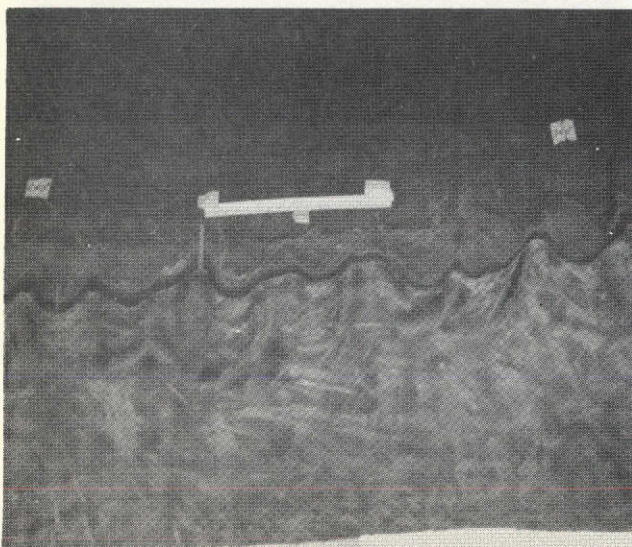
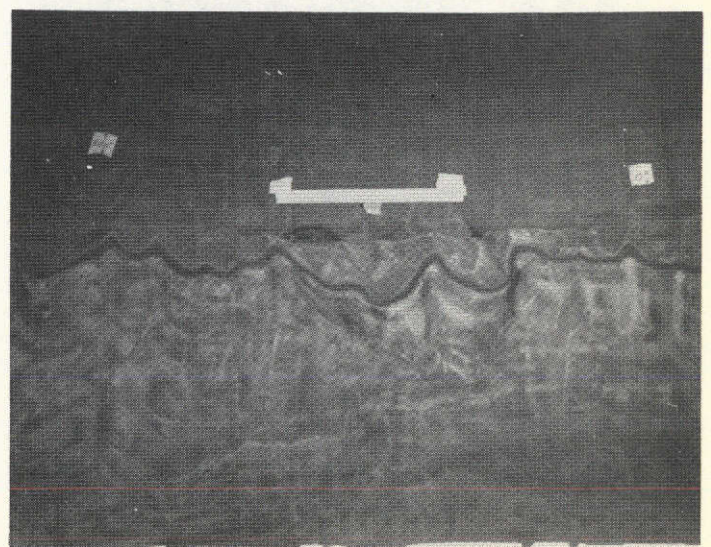
Figure 74

As shown in Figure 74, the erosion contour at the downstream edge of the nozzle insulation, spanning the -2.04:1 area ratio station, was considerably smoother than the 260-SL-1 posttest contour. Apparently, the effort expended to control the nozzle insulation shrinkage in the mandrel during and after cure produced a closer fit with the nozzle plastic components. As a result, a thinner bond line was formed between the rubber and plastic at the blend area, and the irregular erosion experienced in 260-SL-1 from degradation of the rubber-to-plastic bond was averted.

Nozzle Erosion Contour
